An Analysis of Arc Fault Ignition and Mitigation Techniques

FEDERAL AVIATION ADMINISTRATION
William J. Hughes Technical Center
Atlantic City International Airport
NJ 08405

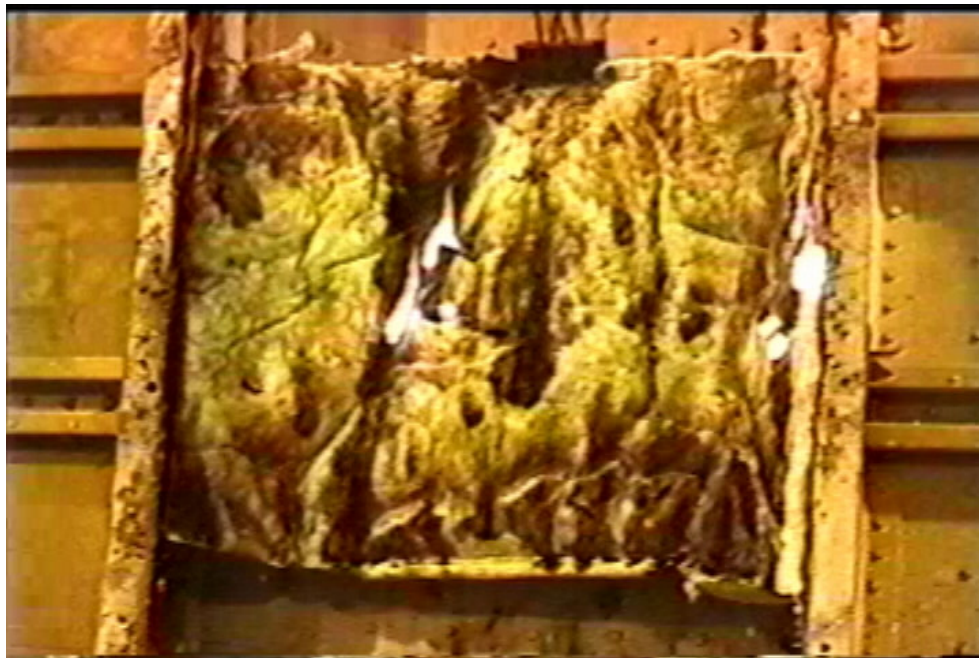
Table 1. Blanket ignition depends upon where the arcing occurred; for example, most ignitions occurred when the edge of the blanket was exposed to the arcing, or the film material edge became exposed due to arcing damage. High-speed video revealed that ignition occurred after charring of the blanket insulation material, and visible flame from the consumption of the out-gassed material occurred. It was difficult to detect whether the ignition occurred from the plasma column of the arcing event or from the molten material (spew). However, in each of the ignitions, a brief visible flame was present and sustained. Damage from the arcing on the different types of blankets is shown in Figures 4. to 7.

Figure 4. Plain Mylar™ 0.6 PCF Arc Damage (front side film totally consumed).

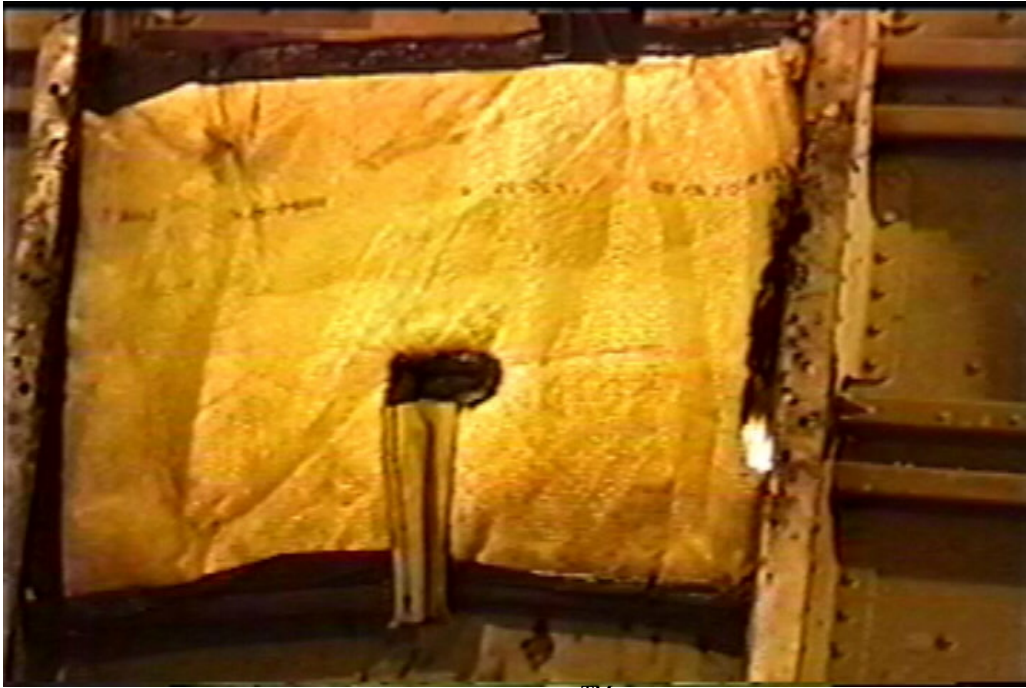
Figure 5. Plain Mylar™ 1.5 PCF
Arc Damage (Only the edge damaged).

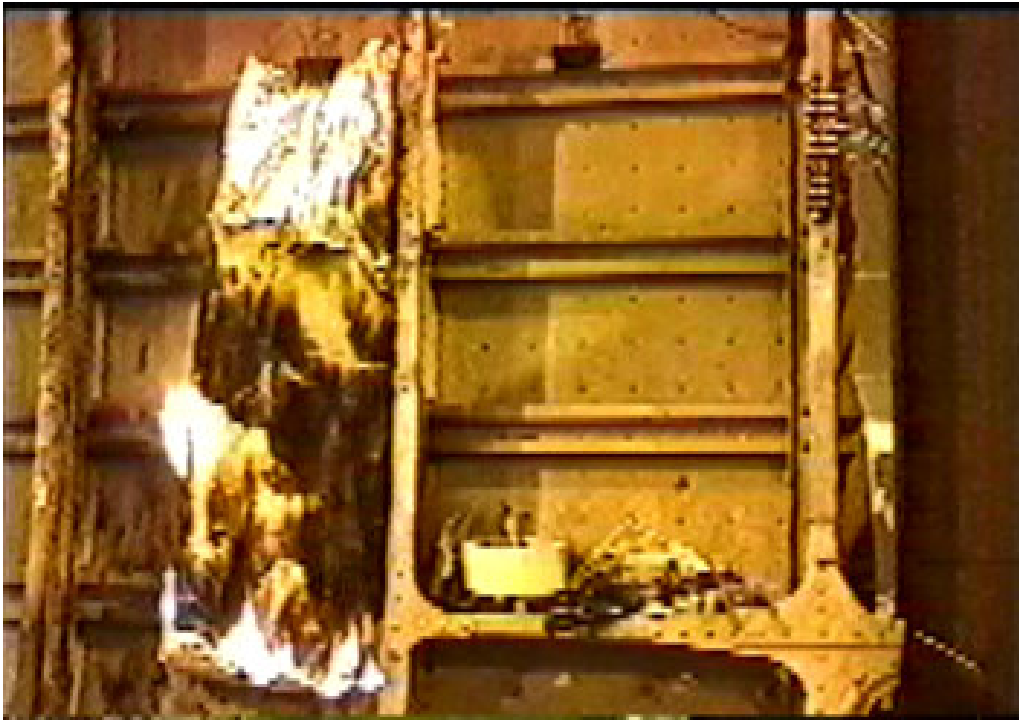
Figure 6. Insufab™ 350 Type K
Arc Damage (Large open flame/both sides of film consumed).

Tests for arc damage mitigation were conducted using the InsufabTM 350 Type K blanket. This type of blanket was selected because it took the least amount of energy to ignite in both the previous FAA tests and in this study. This blanket also showed the greatest amount of damage when ignited by electrical arcing.

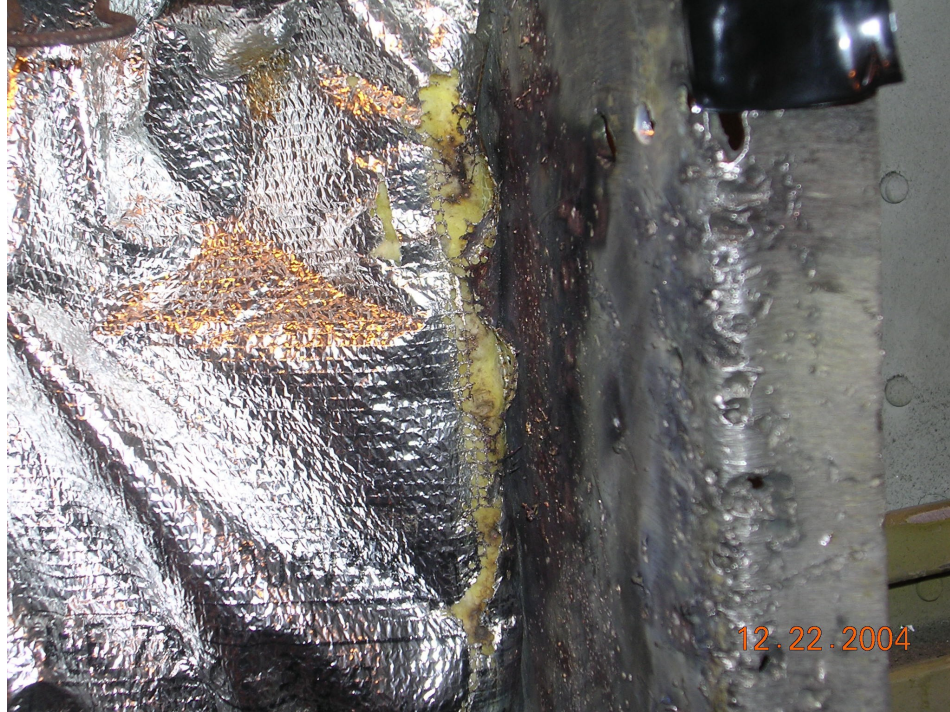
Figure 7. Low current damage to blanket.

The InsufabTM 350 Type K blanket was tested with the fault current reduced, using 100 feet of Number 22 AWG wire. In low-fault current testing set-up sample blankets were tested, as many as ten times, without recurrence of ignition. The range of energy that blankets absorbed, on one particular test run, was approximately 5373 J, as shown in Table 2. The energy increased (in comparison to the high fault current test); however, the arc peaks were reduced from 400 amps to approximately 93 amps. The reduction in fault current amplitude reduced the width of the plasma column. Due to the smaller plasma column, the wire would weld and short for brief periods of time to the frame. The damage obtained by the blanket was minimal; however, some carbonization of the metalized film was noted. At no time during testing did a sustained open flame occur after repeated testing. During examination of the video, occasional small open-flames were noted in the high-speed video.

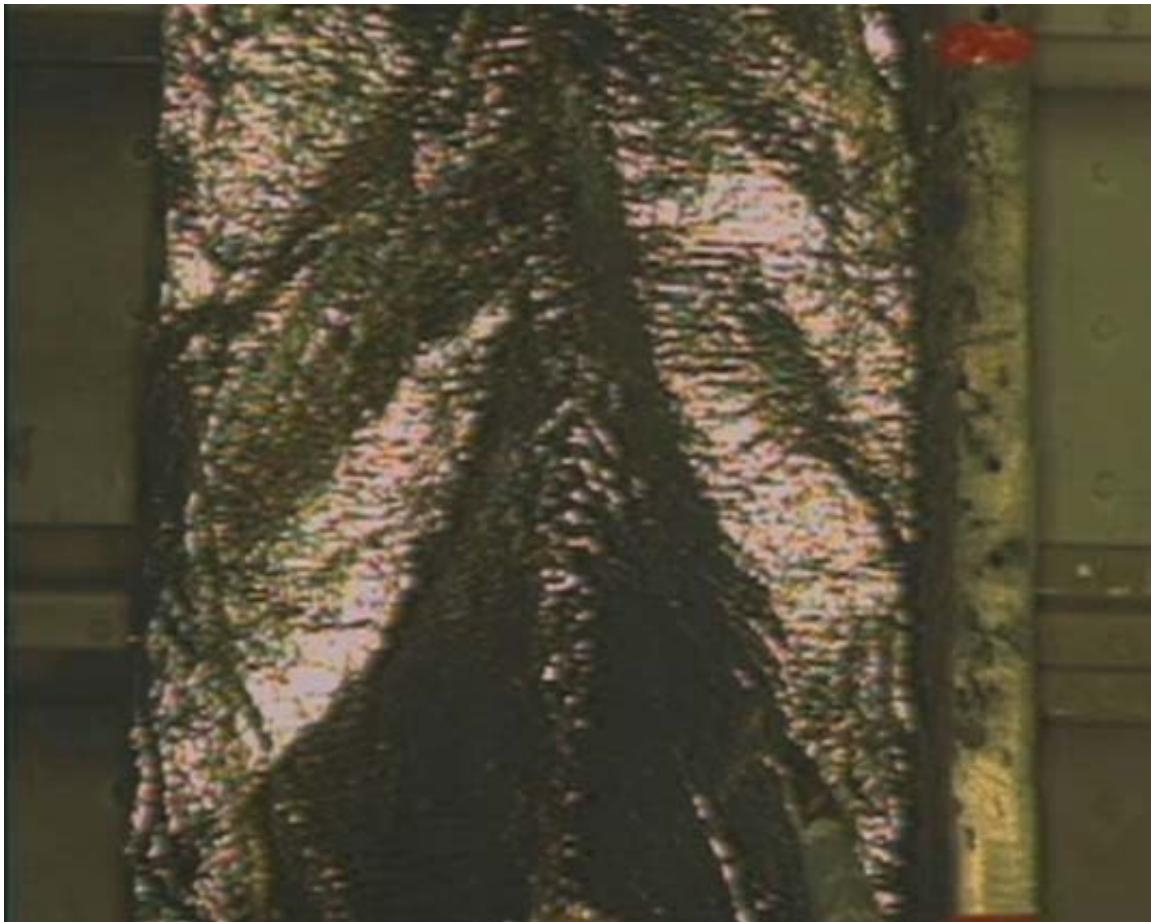
The Insufab™ 350 Type K Blanket was tested using several 7.5amp AFCB from three different manufacturers (see Figure 8.); testing used both high and low currents test set-ups. The energy absorbed by the blanket was reduced dramatically, as shown in Table 3. The amount of damage the blanket obtained was cosmetic (see Figure 9). While one AFCB let 627 J of energy pass before tripping, most of the breakers were tripped with less than half of the energy shown to ignite the blanket. When testing with low-fault current levels, the amount of energy required to trip the AFCB was an order-of-magnitude less than that recorded energy level required to ignite the blanket. Figure 9 shows the damage obtained by the blanket to be minimal.

Figure 9. AFCB Protected Blanket.

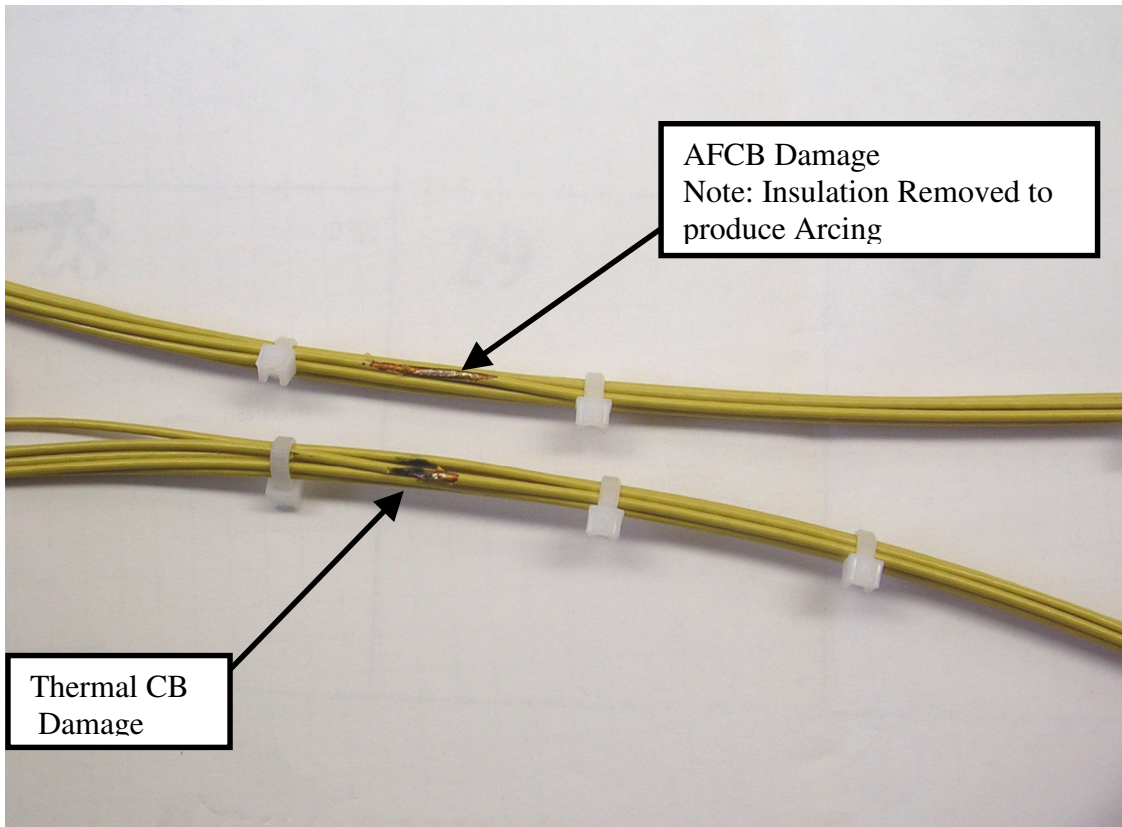
The AFCB worked very well on both low- and high-fault current setups. The amount of damage on the wire bundle was minimal. In some cases, the carbon from the event could only be seen in the close examination of the wire. The AFCB showed more damage when an event included intermittent shorting, along with arcing. High-current events were detected quickly (Figure 13 and 15) and when power was interrupted the event stopped. Low-fault current arcing events protected by an AFCB showed very little damage similar to the high-fault current event (Figure 14 and 15). All of the AFCB protected bundles showed very little damage; however, when testing with low-fault current, sometimes the bundle would tack to the line and the normal thermal protection would prevent further damage.

Figure 13. High-Fault Current Arc Fault Protection.

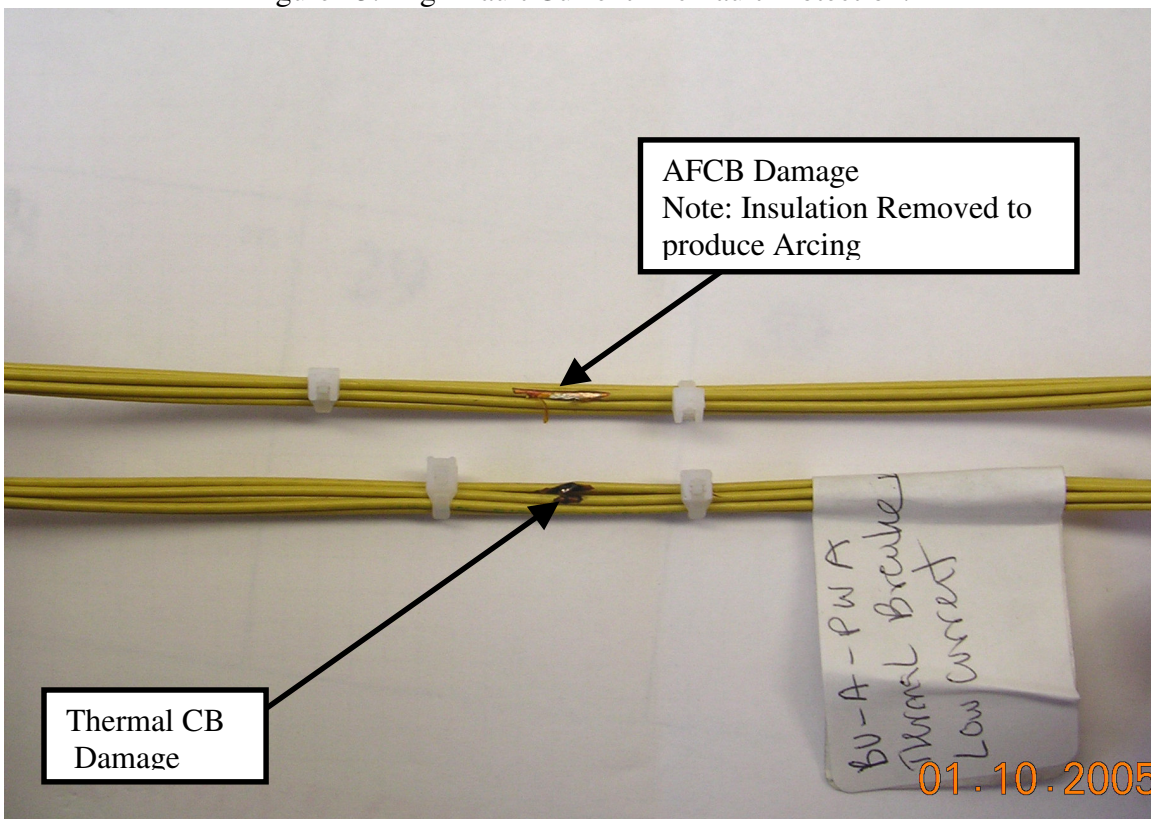
Figure 14. Low fault Current Arc Fault Protection.

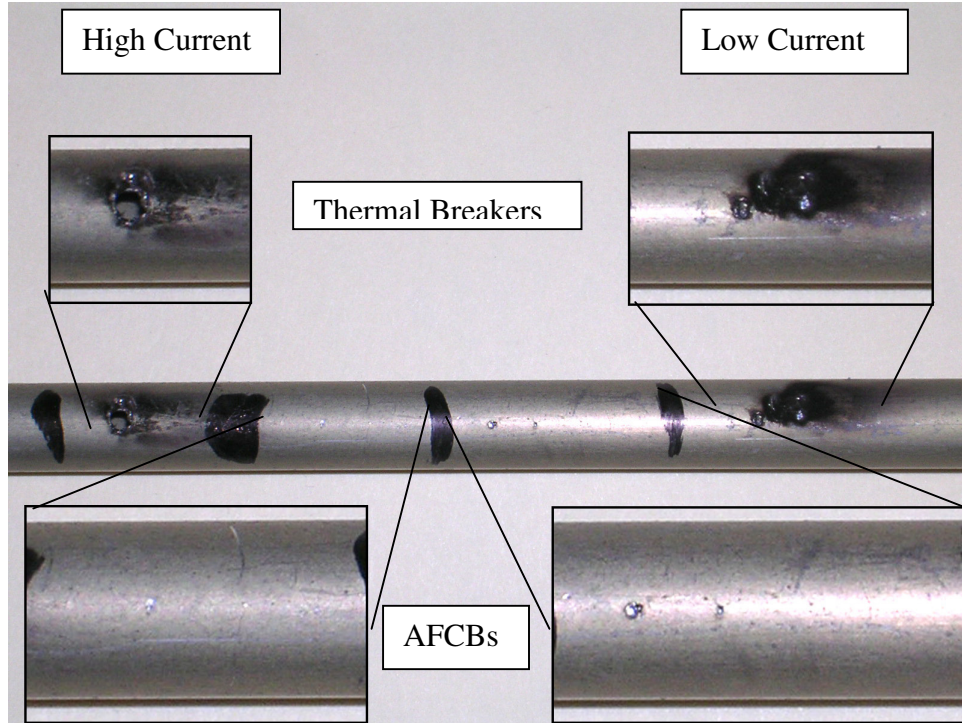
In the tests run, with reduced fault current, both thermal protected and AFCBs had a tendency to weld to the hydraulic line, the tack had to be broken to show arcing effects. Many of the tests showed thermal protection stopped the event before the wire bundle or the hydraulic line was destroyed (Figures 13-15.). The reduction in fault current showed dramatic improvement over the high-fault current thermally protected circuit alone. The damage results were evident on the wire bundle and the hydraulic line.

Figure 15. Hydraulic Line Damage

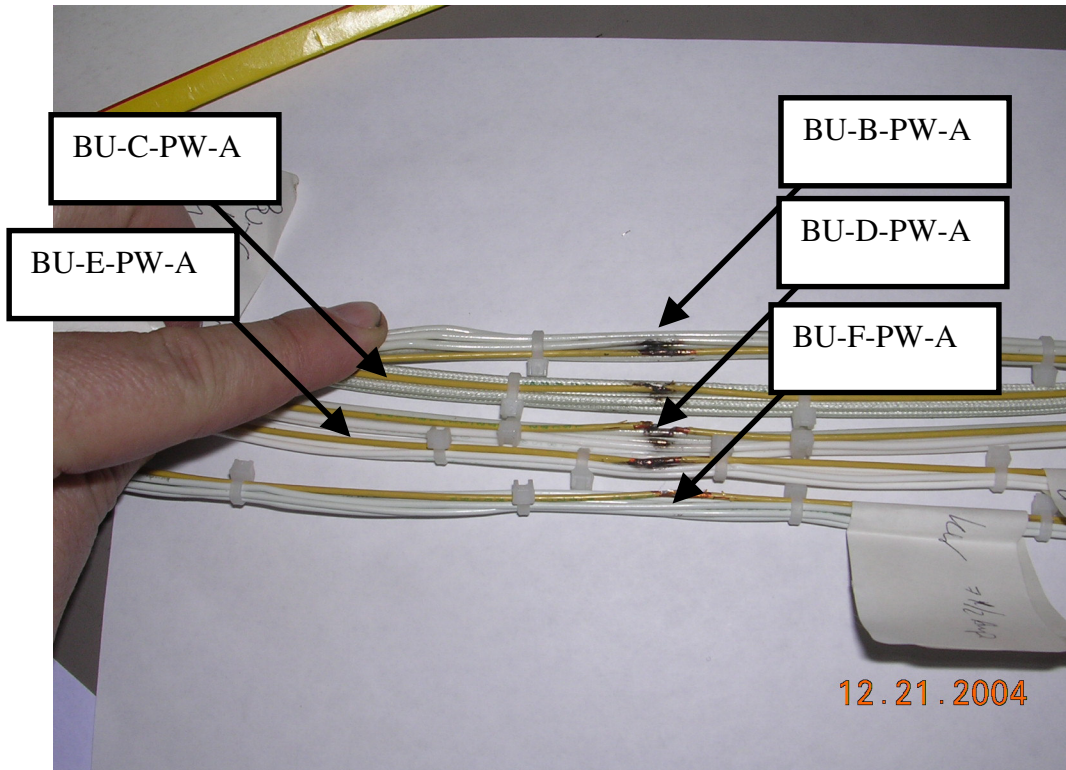
All wire bundles were tested with high-fault current, a polyimide insulated arcing wire, and thermal protection. The results are shown in Table 6 and Figure 16. The PTFE wire showed little or no damage from the arcing polyimide wire. The PVC wire showed some damage and reduction in the insulation from material being melted away.

Bundle Wire Type	Damage
BU-B-PW-A	Damage on Wires 5, 1. Cosmetic Damage on Wire 7
BU-C-PW-A	Damage on Wires 5, 1, 7. Wire 6 Burn Thru
BU-D-PW-A	Damage on Wires 5,1,7. Cosmetic Damage on Wire 2. Wire 6 Burn Thru
BU-E-PWA	Cosmetic Damage on Wires 1, 5, 7
BU-F-PW-A	Cosmetic Damage on Wire 5

Figure 16. High-Fault Current Bundle Tests.
